# **Inspection report**

Inspection damage 300 TPD six stage flash evaporator on the  
Ms Love boat 2

Report nr. 1-2416

Date: 03/04 june 2025

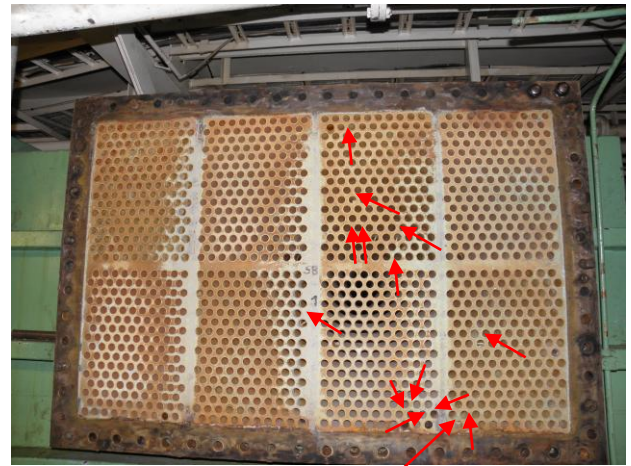
SB1 tube sheet 1 dirt in tubes

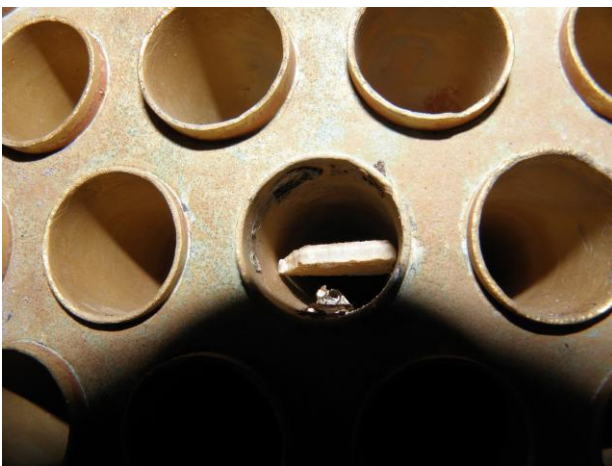
A lot of dirt in some tubes (close up)

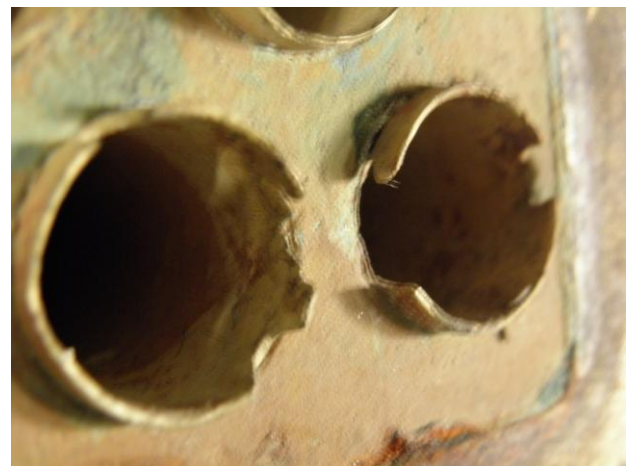
Tubes damaged (close up)

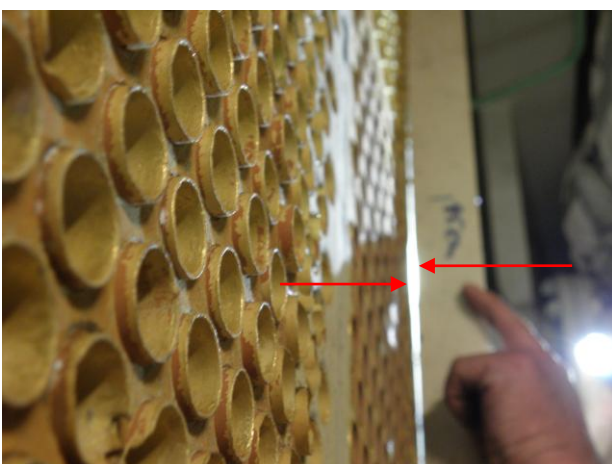
Space between ruler and tube sheet 5 a 6 mm

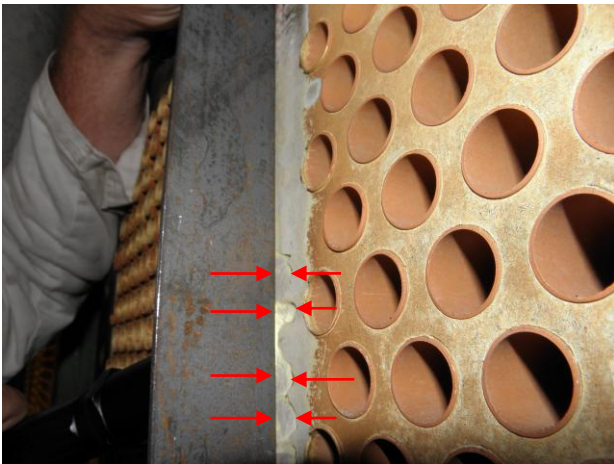
Spaces between ruler and tube sheet

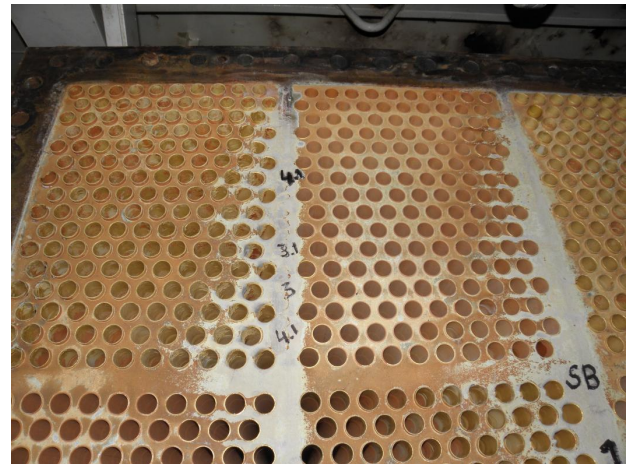
Left	Middle	Right
4,1mm		
3,1mm		
3mm		
4,1mm

Maximum 4.1 mm tube sheet SB 1

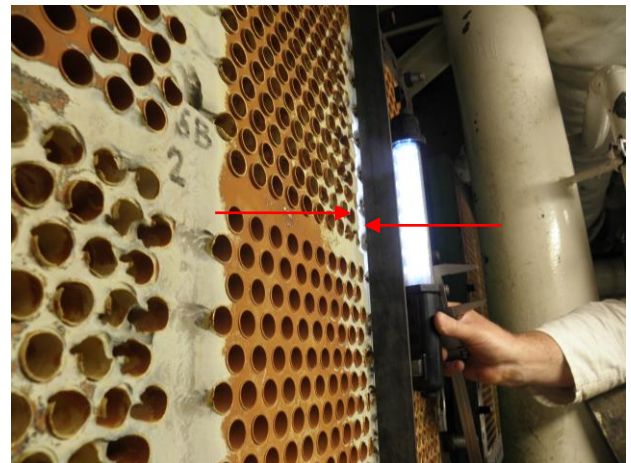
Space between tube sheet and ruler

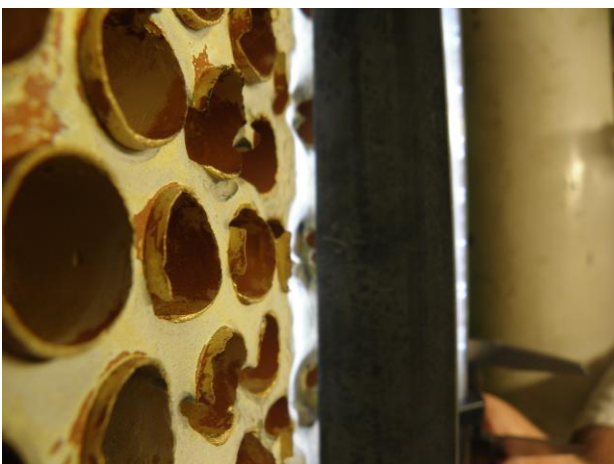
Space 3 to 6 mm

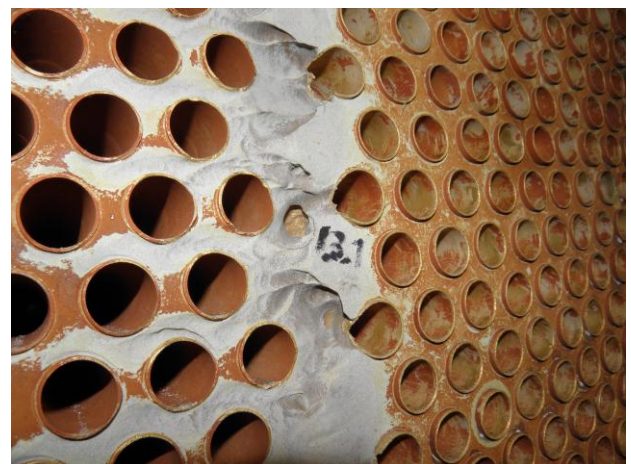
13.1 mm deepest hole

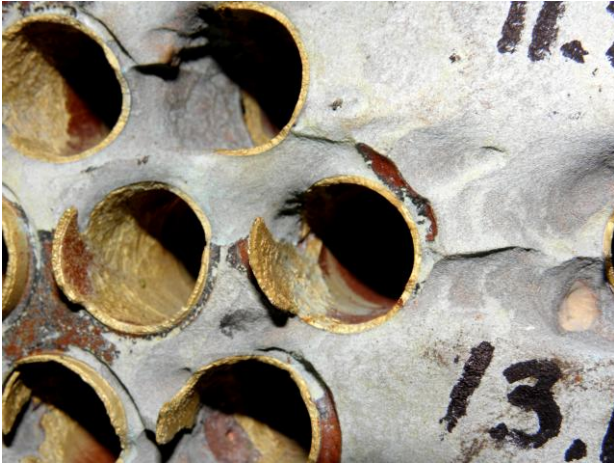
Tubes sheet thickness reduce till 13 mm

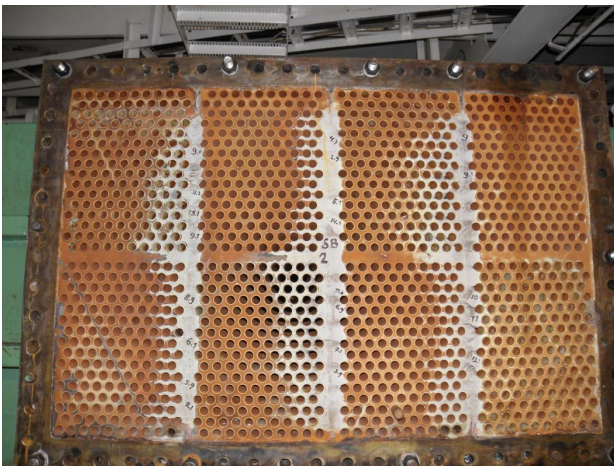
The First impression of the evaporator was the enormous damage of the tube sheets especially the tube sheets SB2 and BB2. The deepest measured hole in the middle of the tube sheet SB2 is 14,1 mm. The deepest hole on the left side of the tube sheet BB2 measured 11,5mm

Max. 14 mm material delivery

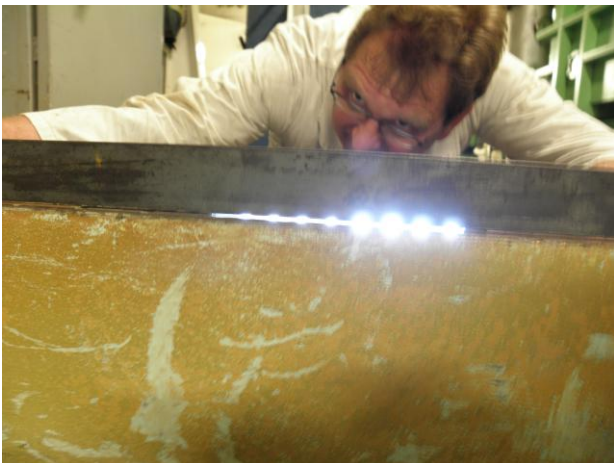
Erosion baffle box SB 2

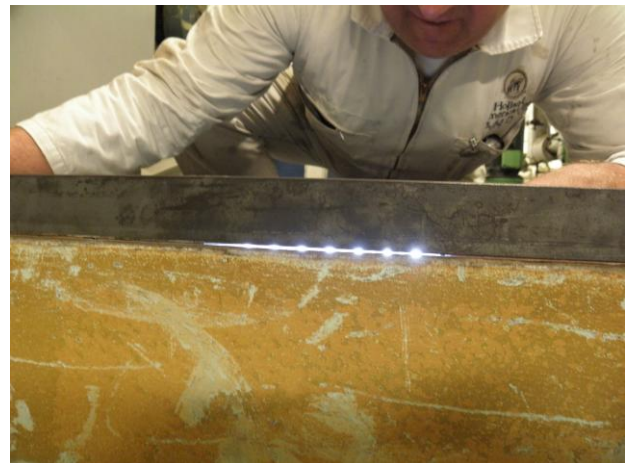
Holes  $\Delta$  3 mm

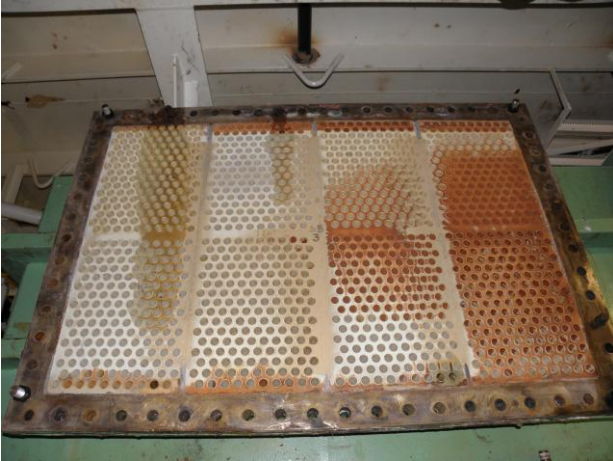
Tube sheet SB 3 no material delivery

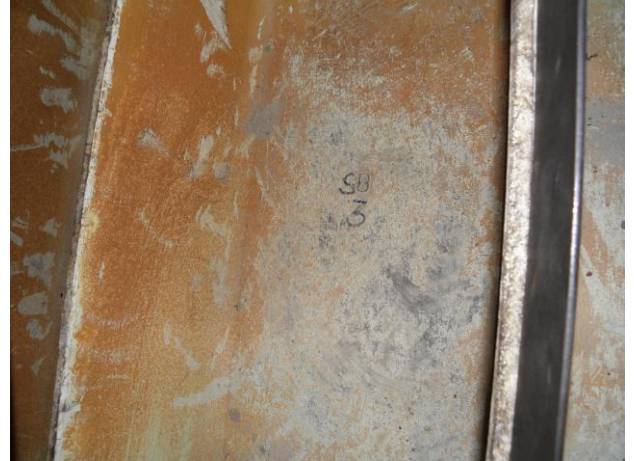
Baffle box SB3 little material delivery

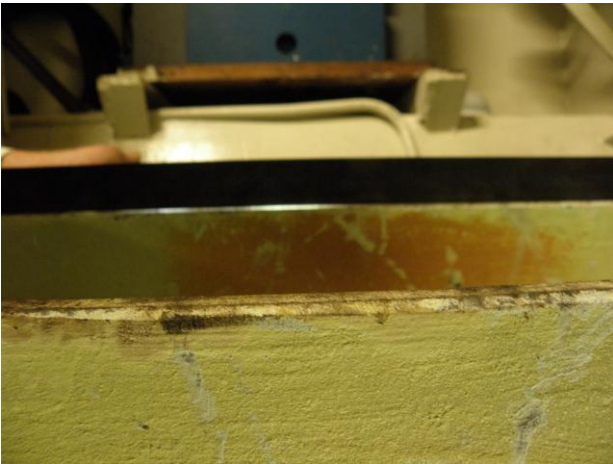
In the middle reducing material (FWD) about 2 a 3 mm

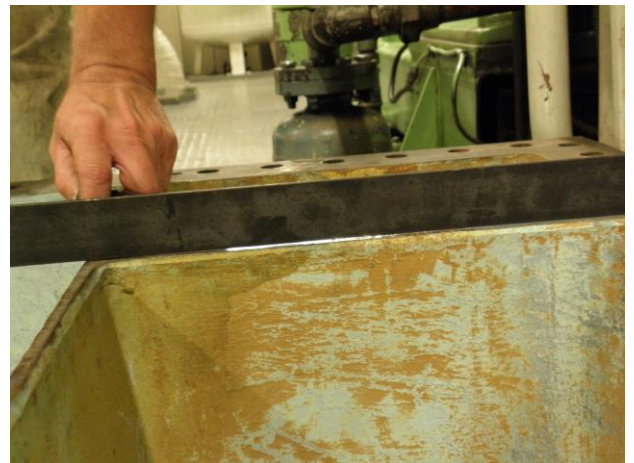
FDW reducing material space 2 a 3 mm

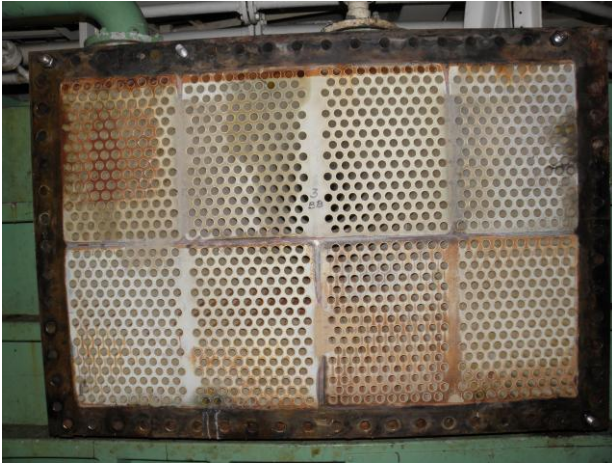
BB3 no material delivery

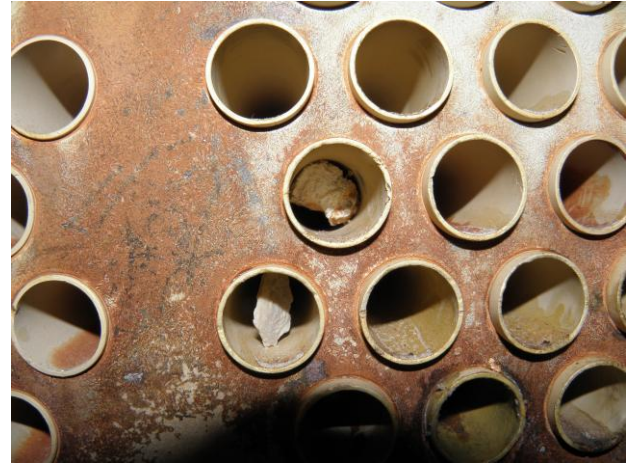
Dirt in some of the tubes

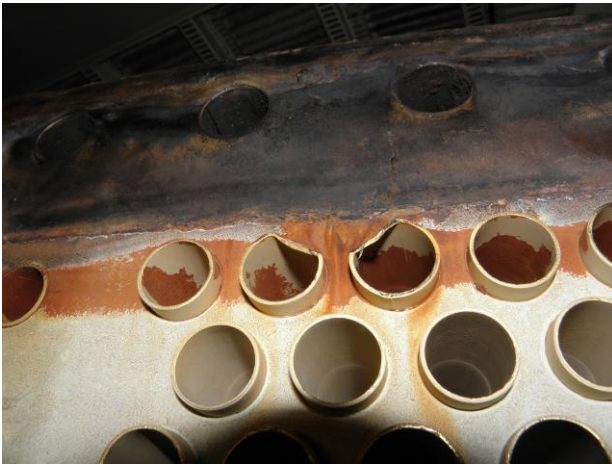
Destruction two tubes

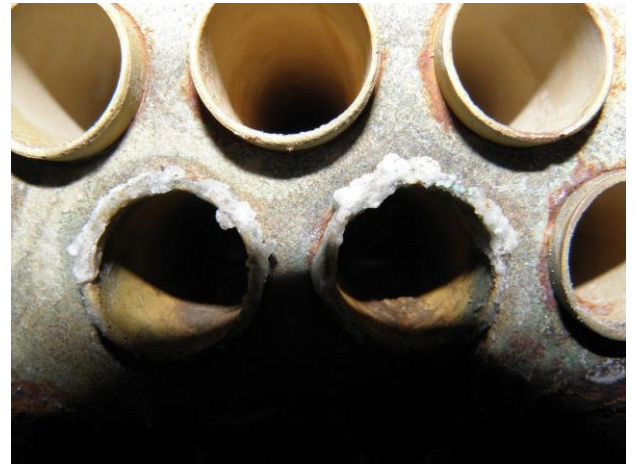
Leakage tubes

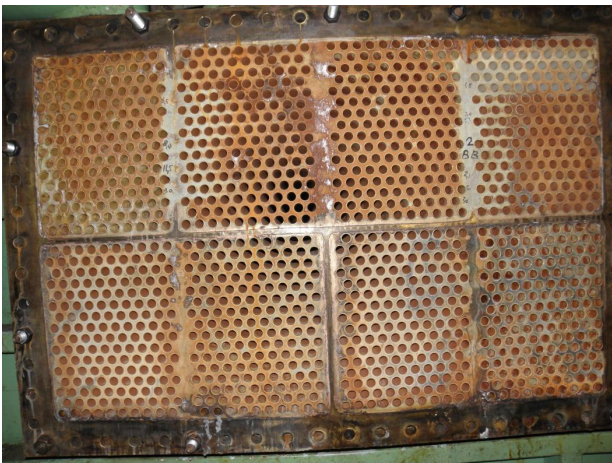
Deepest hole 11.5 mm BB 2

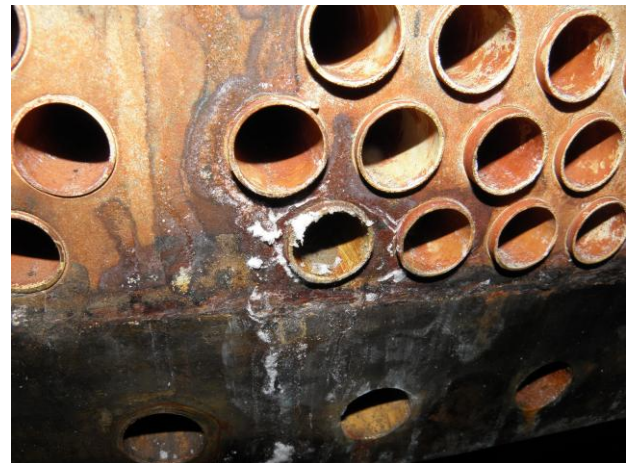
Leakage

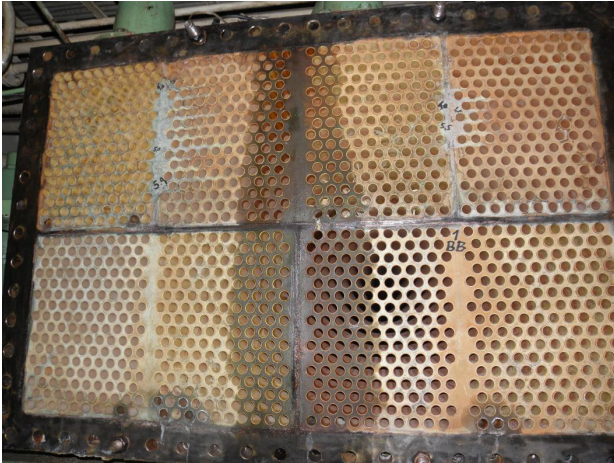
BB 1 deepest hole 6 mm

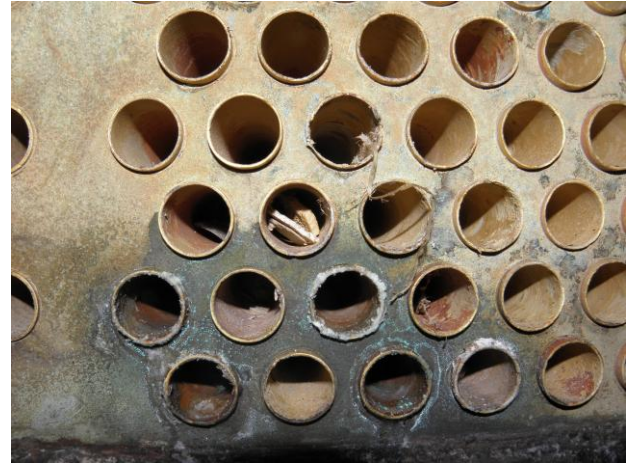
Dirt in tubes

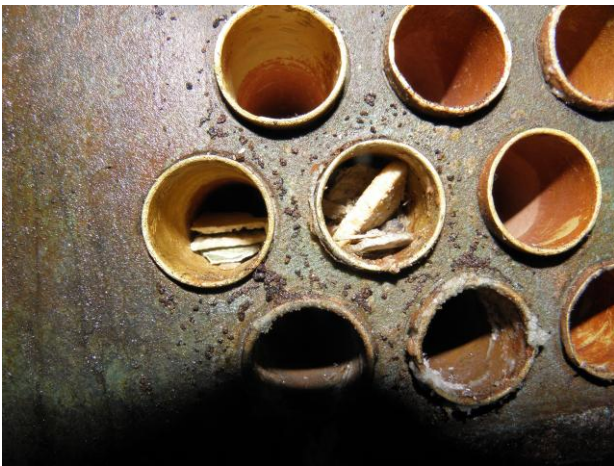
Dirt in tubes

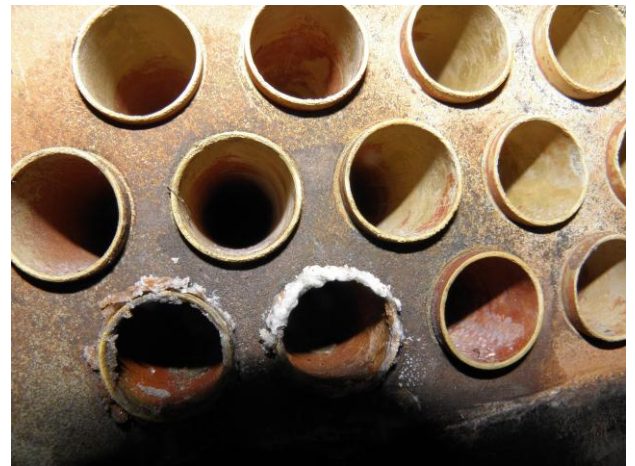
Leakage

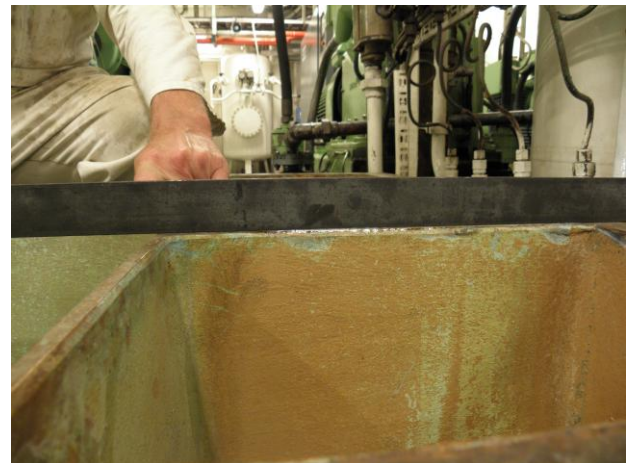
Space between ruler and marine box 1.5 till 3 mm

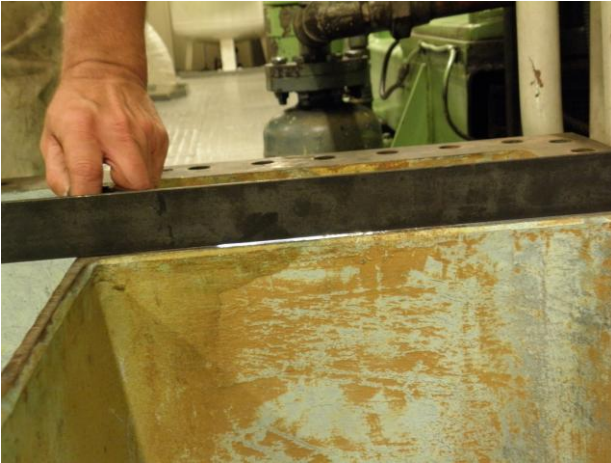
Space between ruler and marine box FDW  $\Delta$  2mm

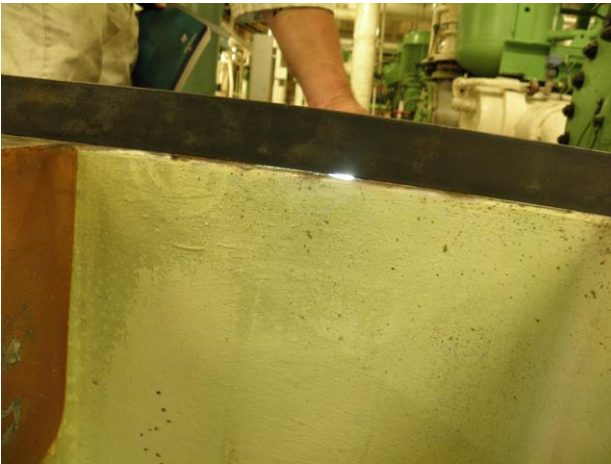
Space between ruler and marine box AFT 3mm

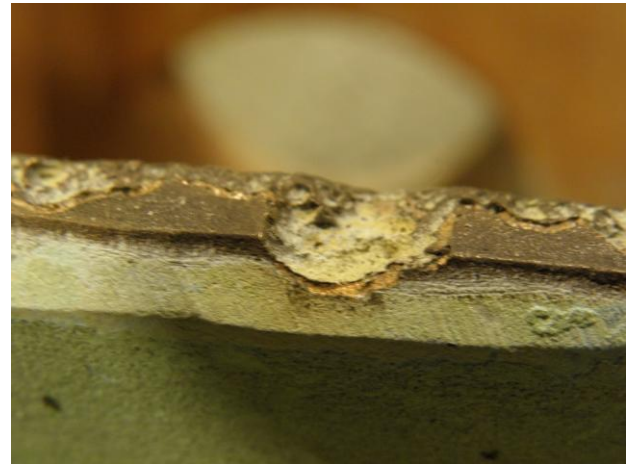
Close up erosion

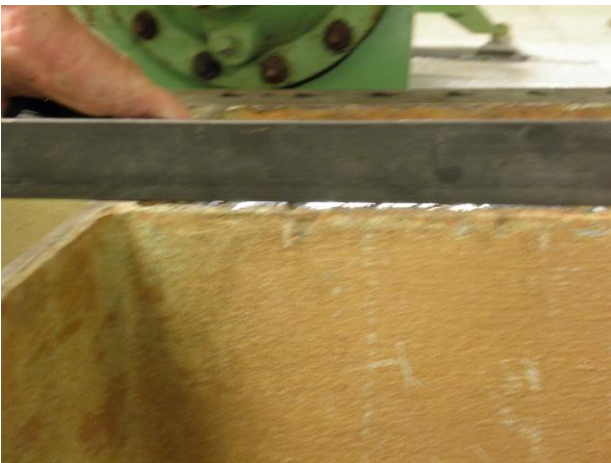
Space between  $\Delta$  2 mm

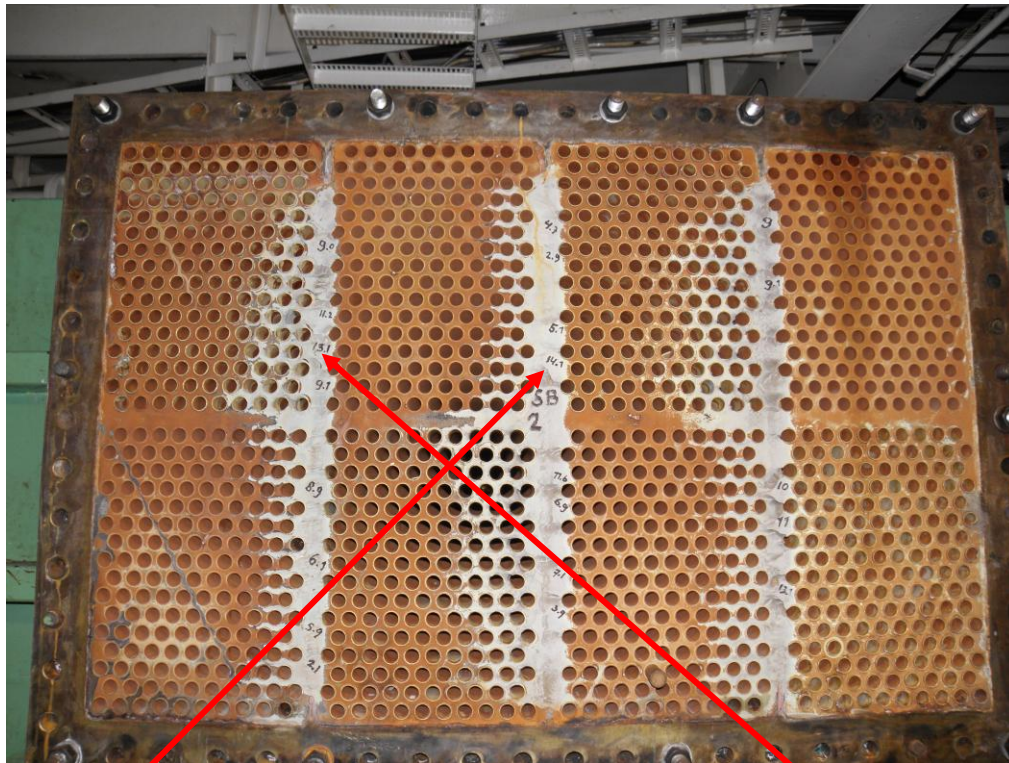
SB2

Left	Middle	Right
9mm	4,7mm	9mm
11,2mm	2,9mm	9,1mm
13,1mm	14,1mm	10mm
9,1mm	11,6mm	11mm
8,9mm	7,1mm	
6,1mm	3,9mm	13,1mm
5,9mm		
2,1mm

14,1 mm in the Middle

The deepest holes

left 13,1 mm

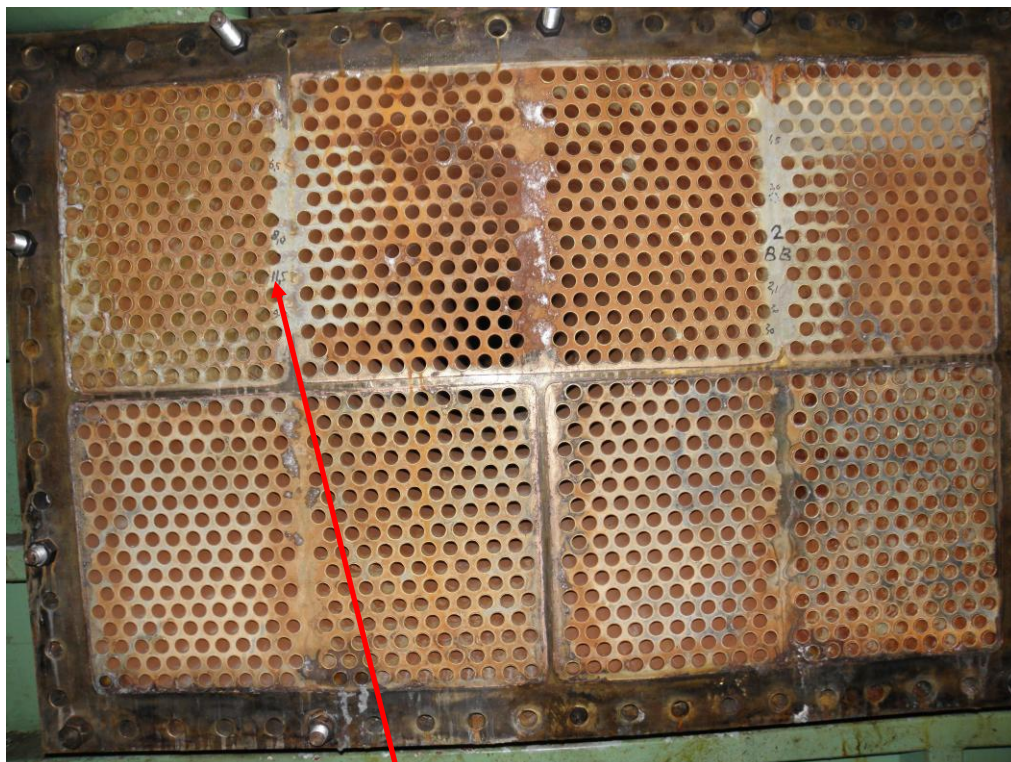
Left	Middle	Right
6,5mm		1,5mm
8mm		3mm
11,5mm		2,1mm
9mm		3,0mm
		3,0mm

BB2 deepest hole 11,5mm

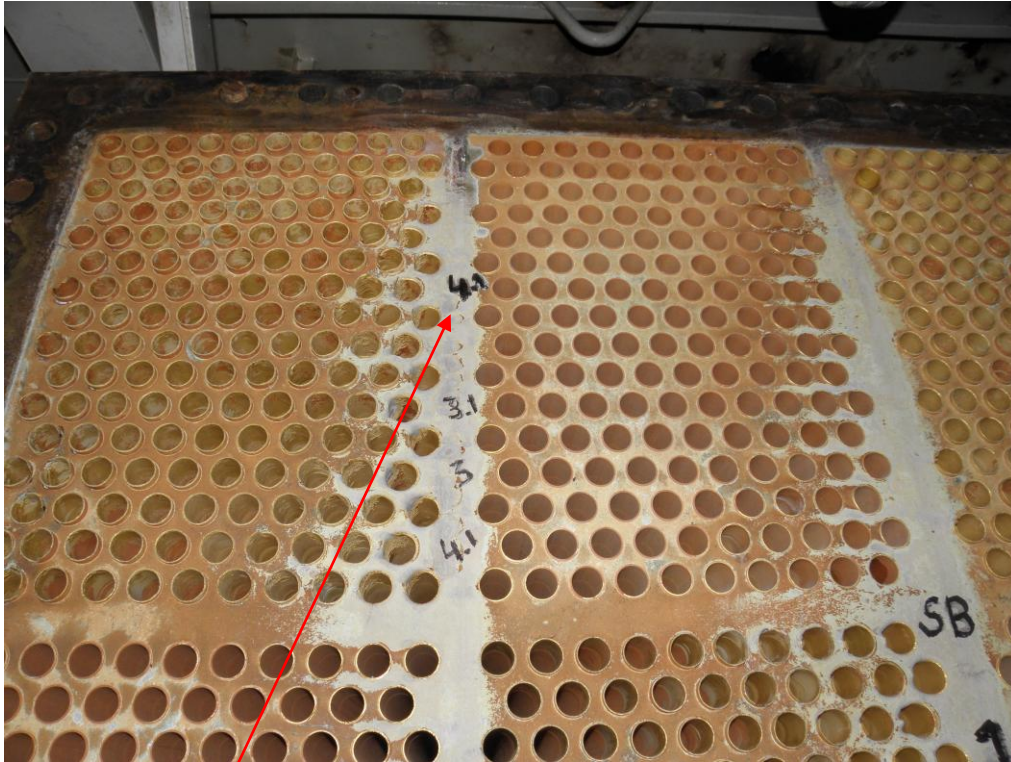
4,1 mm Tube sheet SB1 deepest hole left side

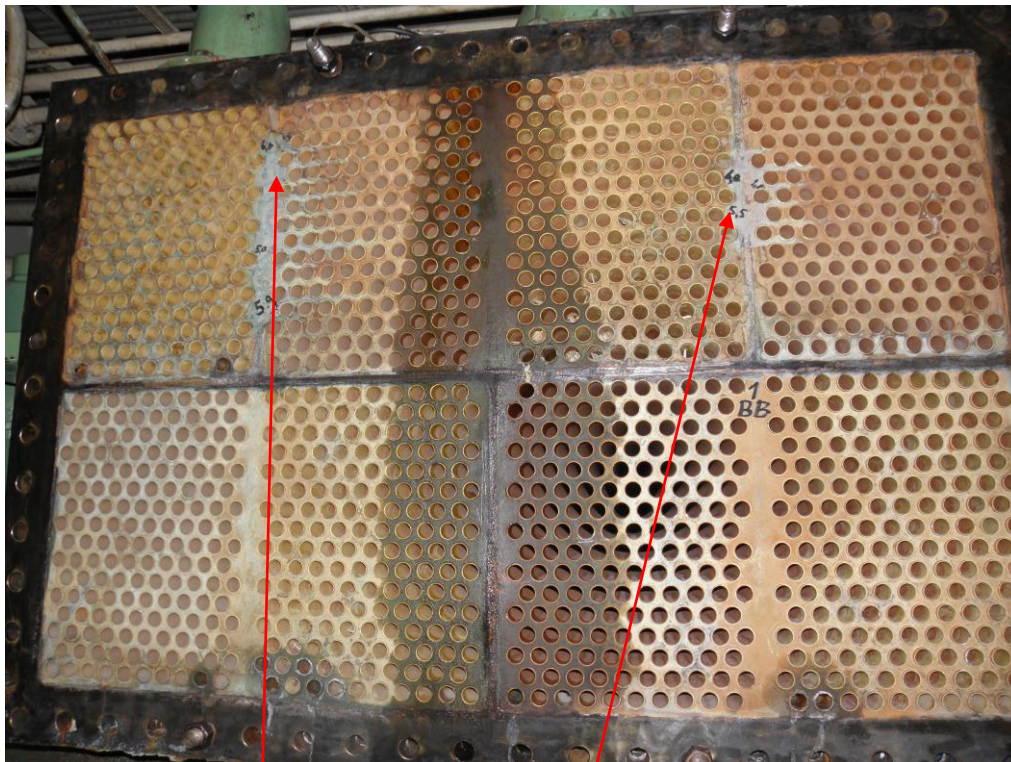
Left	Middle	Right
6,0mm		6.0mm
5mm		5,5mm
5,0mm

BB1 Tube sheet deepest hole 6mm

5,5 mm right side

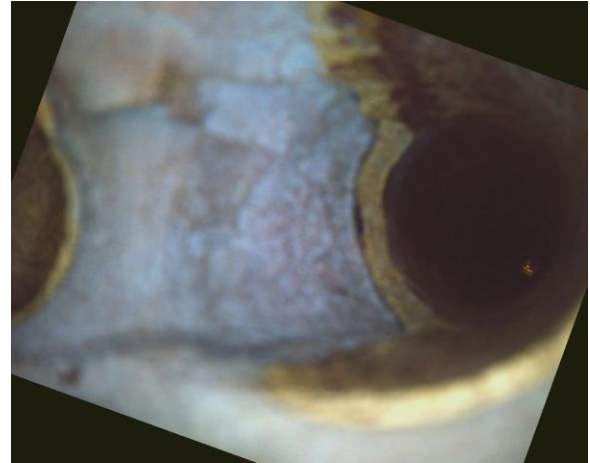
Part of tube removed by erosion
