## ***Investigation report.***

Investigation into the cause of leaks in Stainless steel Pipes  
in a large Beer brewery.

Client: Large Beer brewery.

Report number: 1- 6046

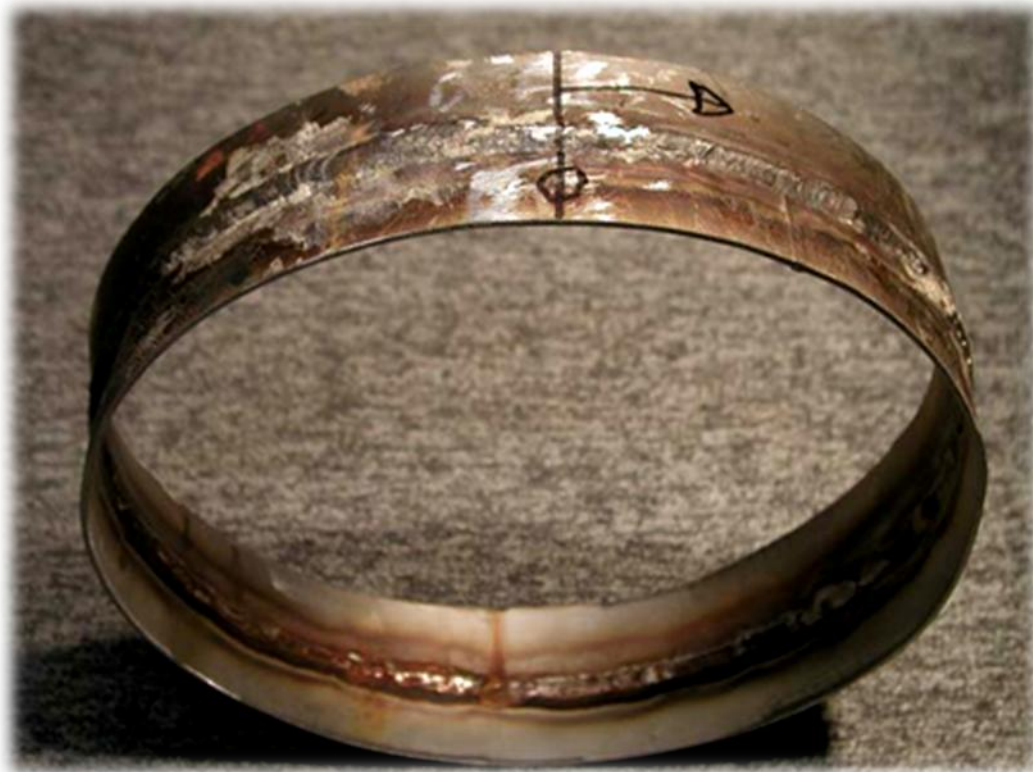
The pipeline section had a width of 60 to 66 mm, with the circumferential weld located approximately in the middle. See (**fig. 1**). The weld joined two pipe sections, one with an outer diameter of 248 to 256 mm and a wall thickness of 2.0 mm, and the other with an outer diameter of 251 to 257 mm and a wall thickness of 2.5 mm. Parts of the weld were not fully penetrated, as had also been shown by the radiographic examination.

**Fig. 1.** Overview of the section with circular weld received for examination.

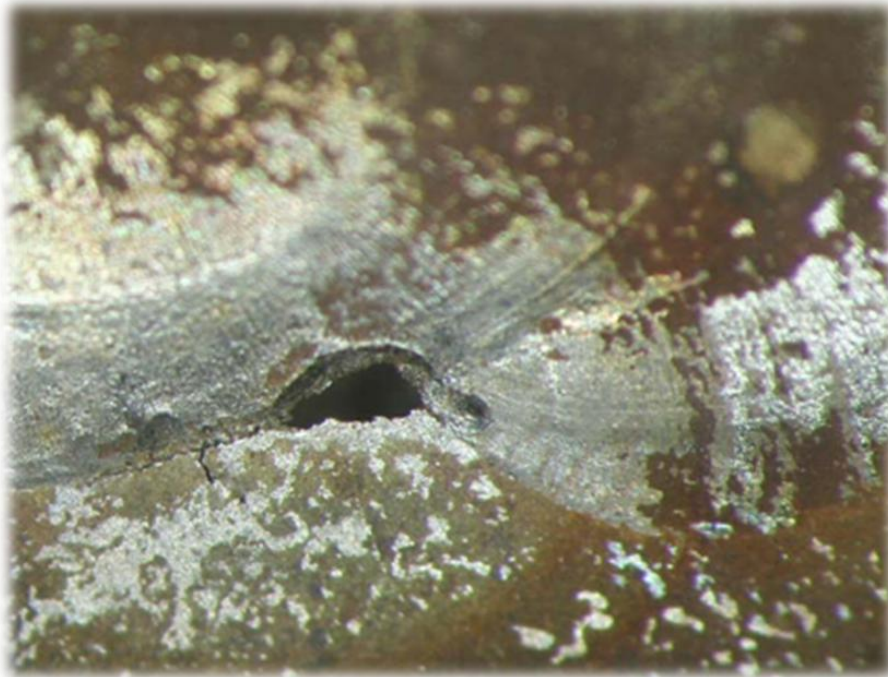
The leak was marked and was located at 133° from the 0-point, on the fusion line on the side of the 2.0 mm thick pipe section. The leak followed the contour of the weld and had an approximately triangular top view with a maximum dimension of about 1 mm. See (**fig. 2**).

**Fig.2.** Inner surface of the section with the leak at the location of the melt line on the 2 mm side. The leak had a size of approx. 1 mm. Magnification: 25x.

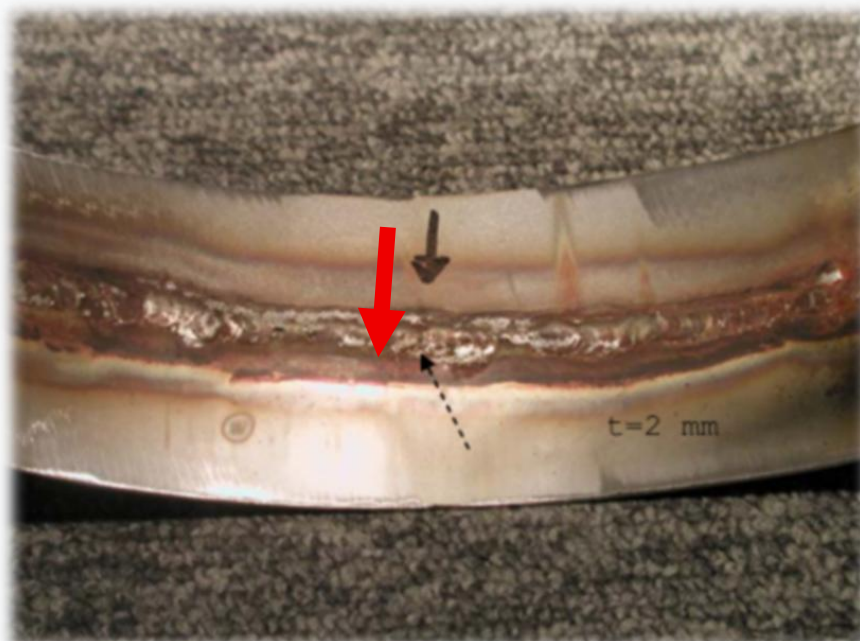
The inner surface of the section showed discoloration in zones on both sides of the weld. The 2.0 mm thick pipe section was dark brown discolored in the area from 290 to 620 mm from the 0-point. The width of this zone was up to 7 mm. see (fig.3). Elsewhere, the zones near to the weld showed slight yellow to blue discoloration up to a width of 12.5 mm, and part of the inner surface was bright.

**Fig. 3.** Black dotted line place leakage, red arrow discolored not passive weld.

To solve the corrosion problem, it is recommended to pickle and passivate the inner surface of the pipe near the welds. Existing corrosion pits will not be re-passivated by such treatment and must be removed by grinding before pickling and passivation.

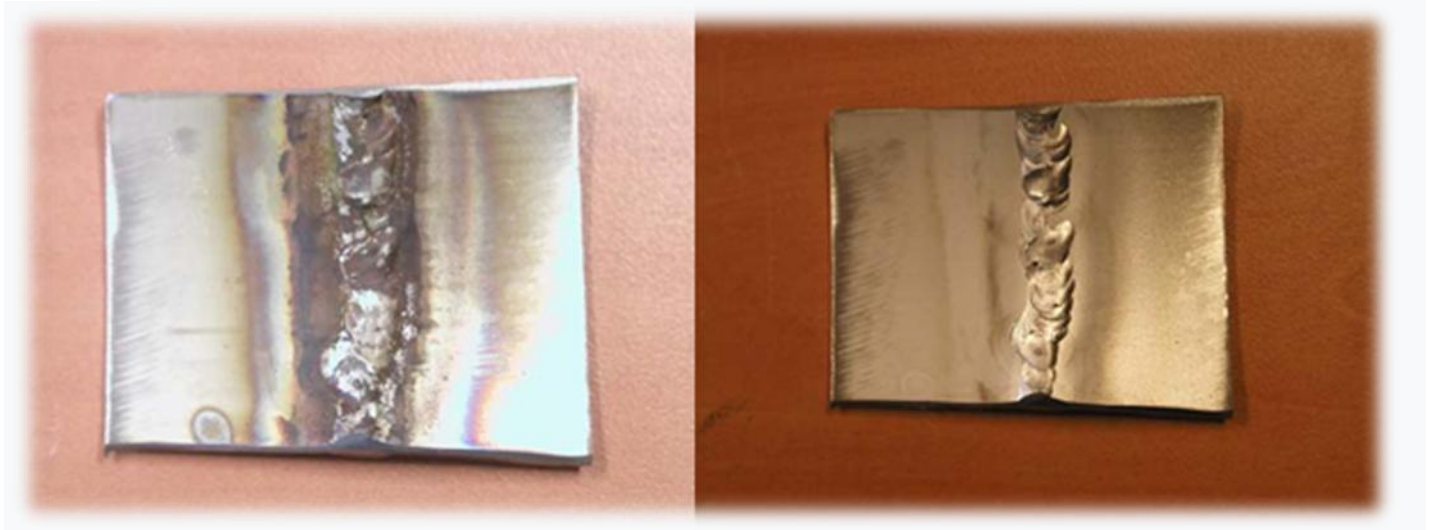
Part of the section was pickled by Cobra Consultancy in a stagnant solution of 20 vol% concentrated nitric acid (69%) and 2 vol% concentrated hydrofluoric acid (40%) in demineralized water. The heat tint proved to be easily removable. See (fig.4)

**Fig. 4.** Left part of discolored before pickling. Right after pickling Cobra Consultancy.

The oxide layer is restored as a result, reducing the risk of corrosion deposits.

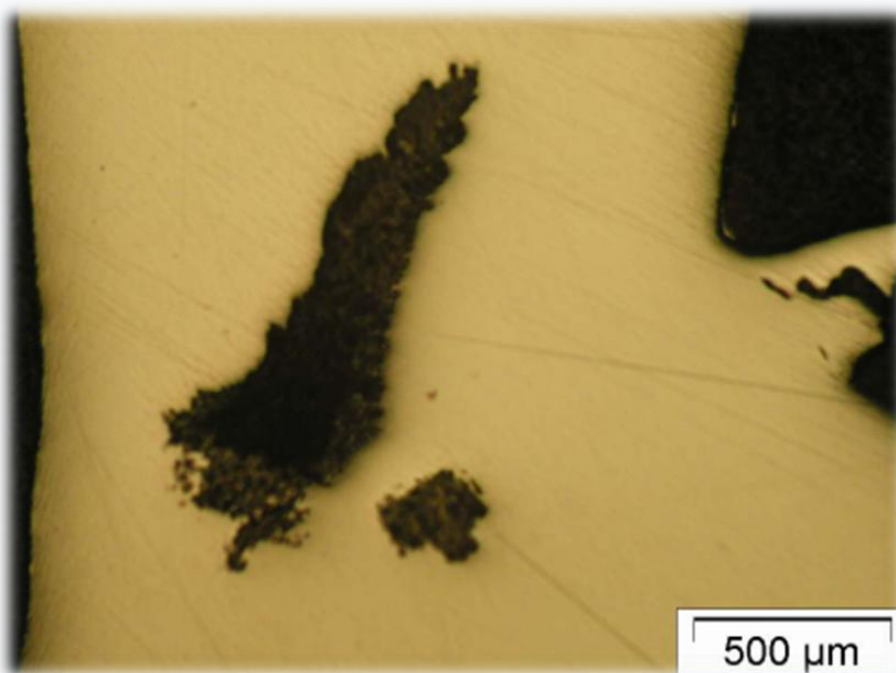
1. Through the leak: The leak appears to have originated at the inner side of the pipe. The surface is heavily undercut beneath the hole. The hole runs partly along the fusion line and partly into the weld. It was found to be filled with grey corrosion product. See (fig. 5)
2. At the location of a misalignment (hi-low). See (fig.6).
3. At the location of a misalignment (hi-low). See (fig.6).
4. From a good part (right) of the weld. See (fig.6).

**Fig.5.** Cross-section next to the leak. The leak was undercut and filled with corrosion product.

Deformation had occurred on the outer surface (right) due to scratches made to locate the leak.

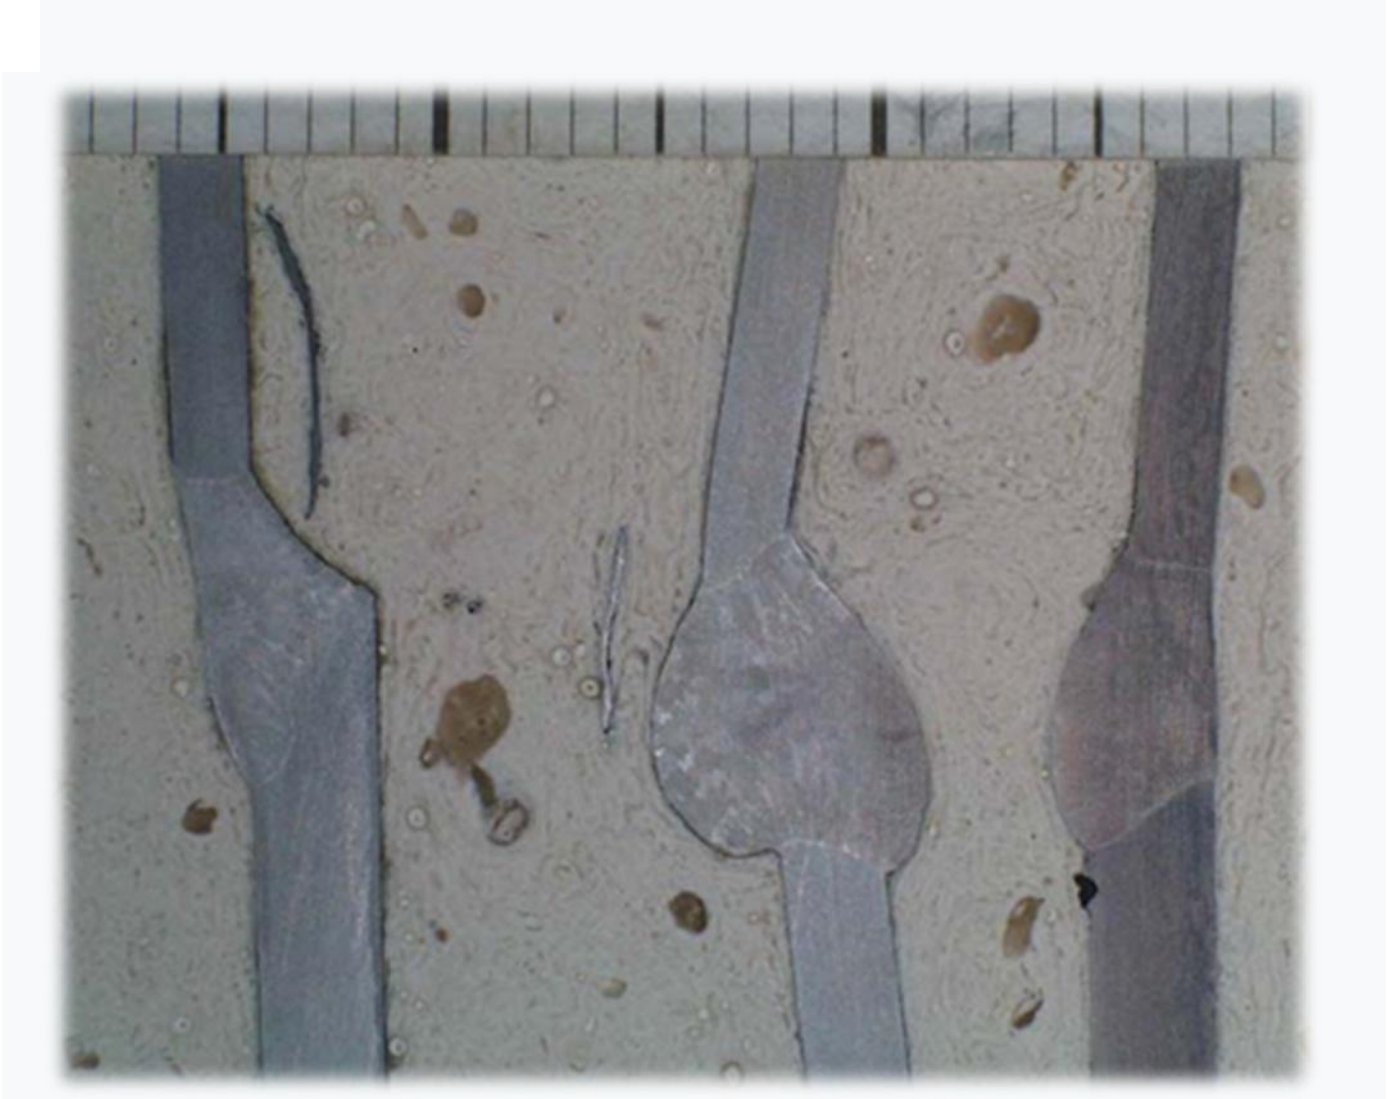
**Fig. 6.** Prepared cross-sections at the point of alignment (left, center) and a good (right) part of the weld.
