Investigation report

Investigation of broken parts of heatshields from turbocharges passenger ship MS. Love boat.

Author: J. van Duijn Cobra Consultancy

Report nr. 1-4399

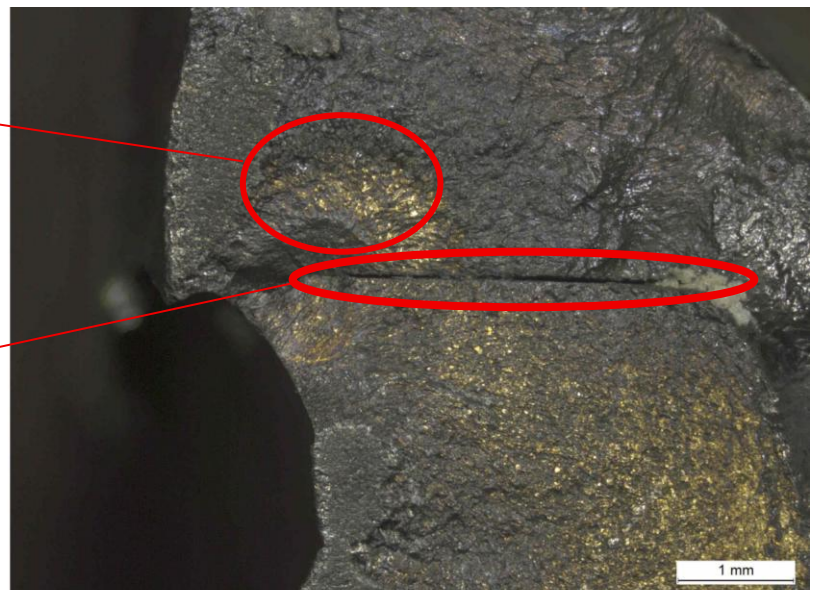
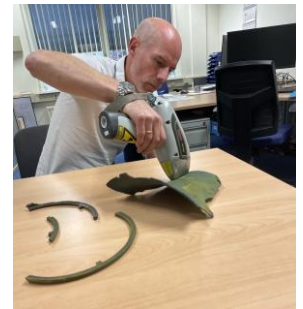
Fatigue

Notch

Figure 10 Macrophoto of fracture surface C in R3, location see figure 8.
Magnification: approx. 16X **After cleaning.**

Many details were damaged on the circumferential fracture between the ring and the cone, and on the fractures and cracks in the cone. Microscopic examination showed trans granular crack paths, which could indicate fatigue fracture. The circumferential fracture seems to have initiated in the inner weld. A small weld penetration could have contributed to this fracture. The fractures in the cone seem to have initiated at the outer cone surface. This surface contains surface imperfections (laps) that probably originate from the spin forming process. Such laps can act as crack initiations. The transverse fractures in the ring show beach marks and the crack path is trans granular. These are in general indications for fatigue fracture. Macroscopic and microscopic examination show that the transverse fractures in the rings initiated at the inner welds. Microscopic examination showed that fracture A initiated at a sudden transition in penetration depth of the weld. Fracture C initiated on a part of the inner weld with very little penetration. **In our opinion these weld imperfections could be the cause of the transverse ring cracks.**

- The cause of the fractures of the rings is caused by fatigue, because not a total penetration or welding has taken place. See Macro photo Figure 10. **Fatigue** and a crack or **notch**.
- The vibrations of the motor accelerate the breaking of the rings.

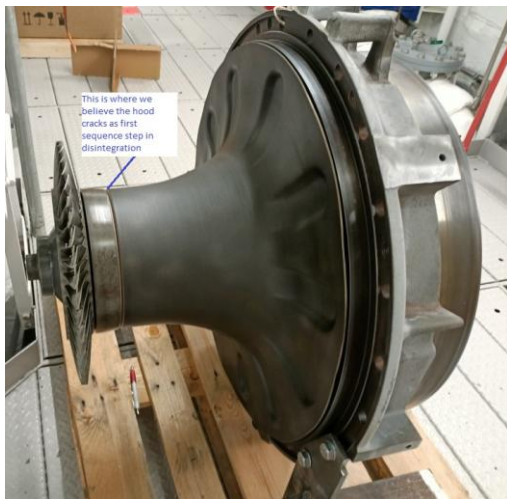
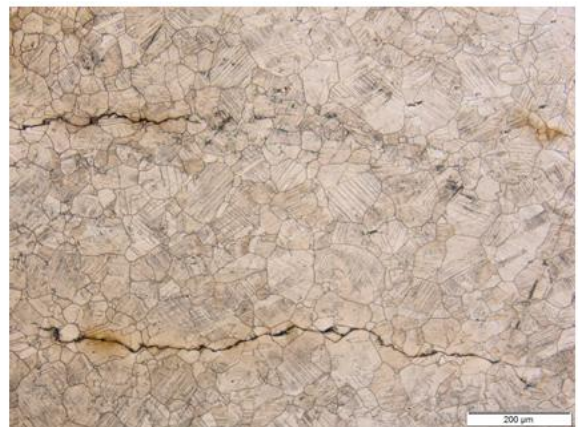
Figure 34 Micrograph of section C1-a, location see figure 22.
Transgranular cracks in the cone
Magnification: approx. 100X **Etching reagent:** HNO₃ + V2A.
