# Onderzoek conform Bouwbesluit RVS onderzoeksplicht bouwbesluit Staatscourant VEILIGHEID Artikel 5.12 Zwembaden

# Corrosion Atlas

THIRD, EXPANDED AND REVISED EDITION

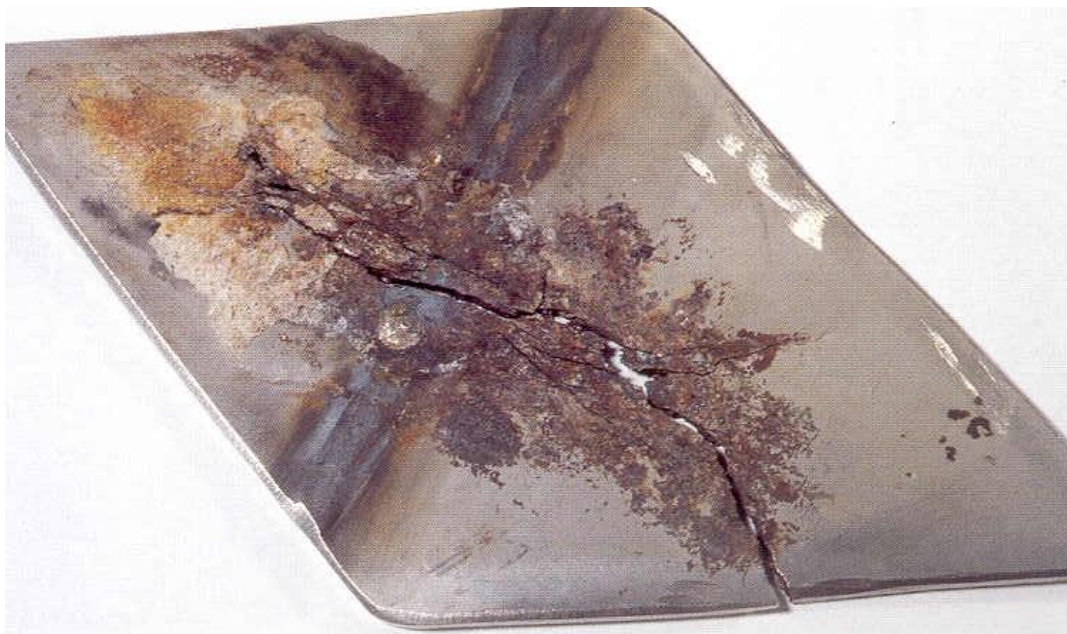
Spanningscorrosie van Roestvaststaal AISI 1.4435 in een inspuitskanaal van calciumchloride.

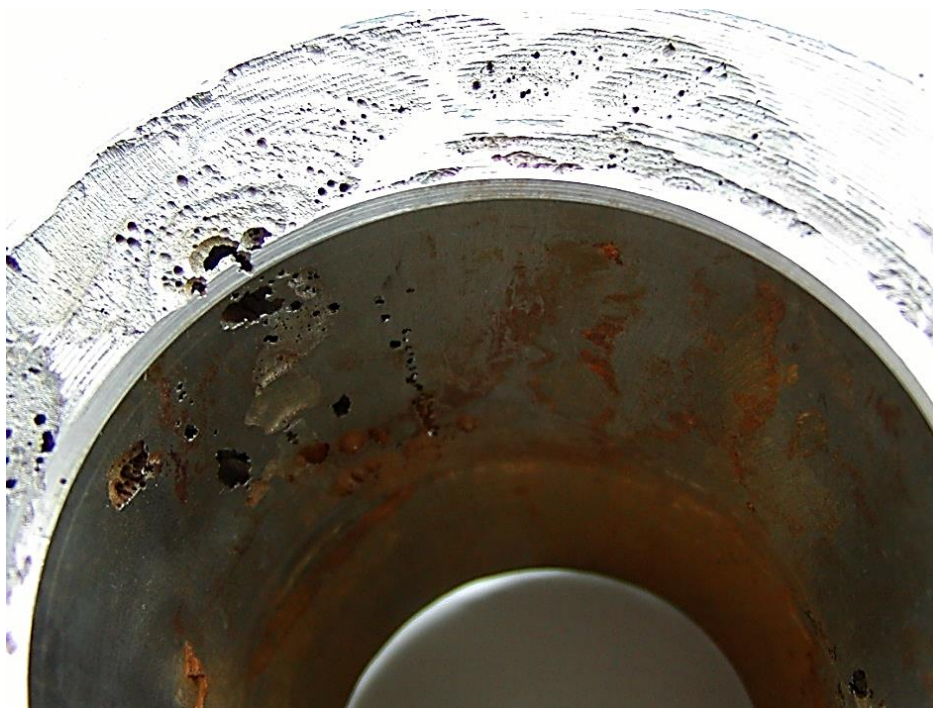
Putcorrosie in een AISI 316 roestvaststalen leiding van een 80°C brouwatertank
