Stress corrosion cracking

of stainless steels in indoor pools

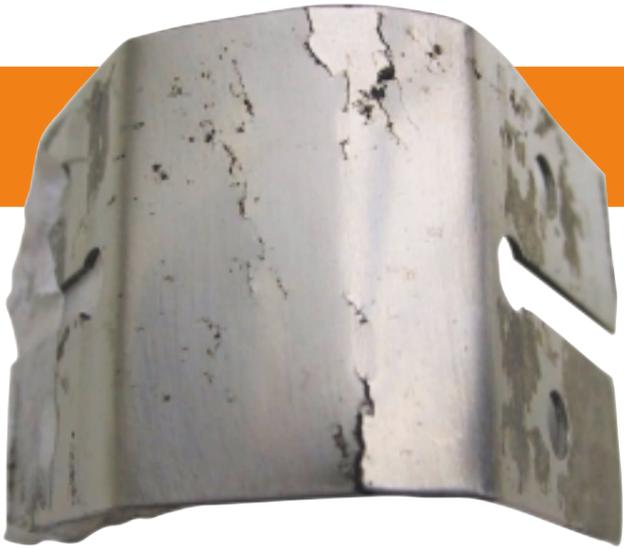
Element in stainless steel ceiling hook. The rust spots have been removed. Below rust spots, the material appears to be full of (micro) cracks. The sheet material has been cold-formed and is therefore full of internal stresses.

- 4 Cold-worked stainless steels, such as fasteners, bolts, elements in ceiling hooks, etc., were often found to have stress corrosion cracks under the corroded spots.

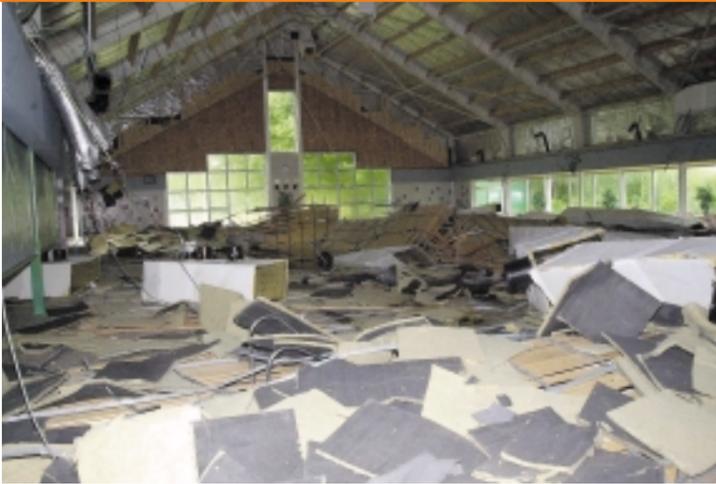
The swimming pool at Steenwijk (The Netherlands) the day after the accident.

Soon after the accident in The Netherlands, its cause became clear. Air channels above the ceiling, weighing hundreds of kilograms, had fallen onto the ceiling, which could not bear the weight of this shock and consequently collapsed as well. The air channels were suspended from stainless steel type 304 threaded bars which appeared to contain many stress corrosion cracks. The conclusion was that stress corrosion cracking of the stainless steel bars had caused the accident. Also in Uster the accident was caused by stress corrosion cracking in AISI 304 stainless steel bars supporting the roof.

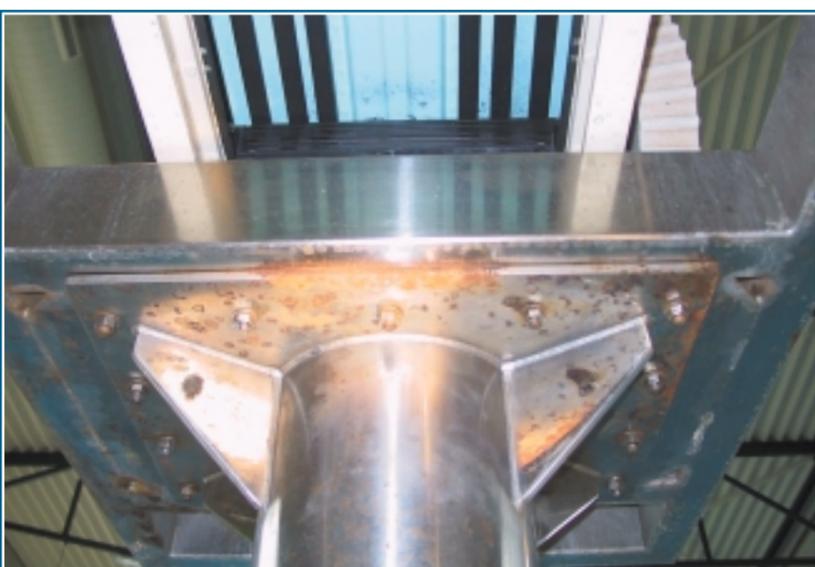
Rusted stainless steel AISI 316 construction, after six months' use.

- 3 In the atmosphere, not under water, most standard grades stainless steel corroded. Both AISI 304 (A2) and AISI 316 (A4) elements corroded, not much difference being notified between each of them.
