***Investigation report microbiology corrosion Stainless steel***

***Wine tanks and heat exchangers.***

Auteur: J. van Duijn Cobra Consultancy

Report number: 1- 15043

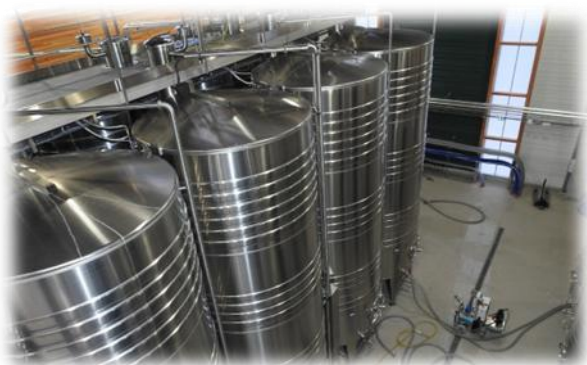
Stainless steel AISI 304 winetanks

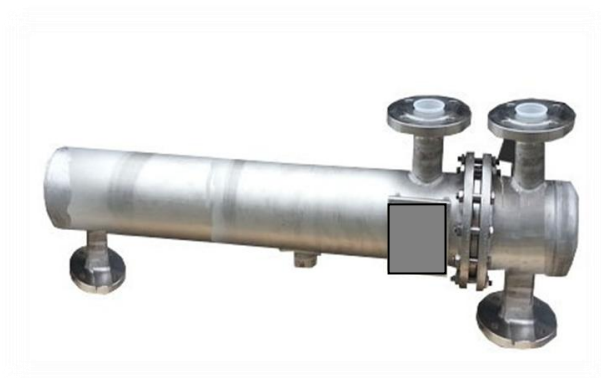
Stainless steel AISI 316 heat exchanger

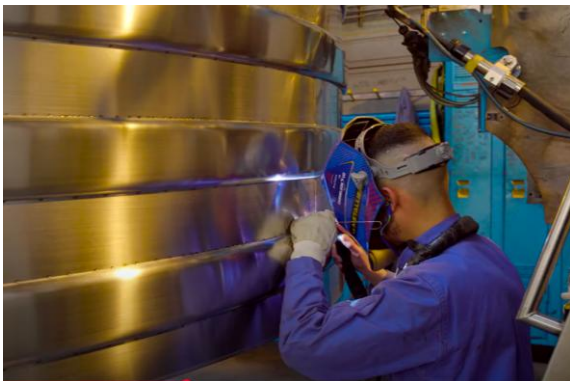
Tack welds

The cooling fins are first tack-welded around the circumference and then automatically welded around the circumference (orbital welding). See photos.

During the welding of the stainless steel cooling fins, one should purge or make the inside oxygen-free, for example, with argon gas. However, this is difficult to achieve during this welding procedure, which is all the more reason to pickle the welds after welding.

If this has not been done, corrosion can occur more readily, especially because the so-called heat-affected zone next to the weld is more susceptible to corrosion.

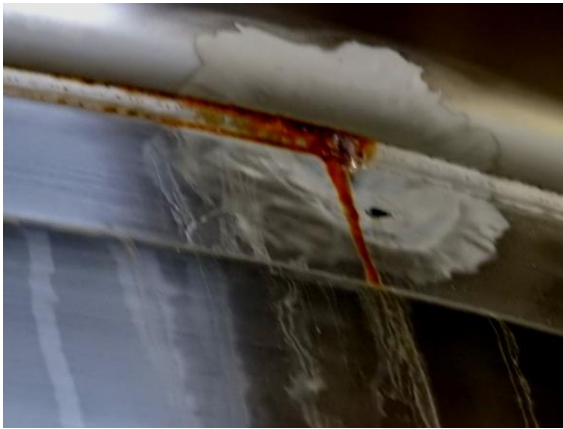
Leakage

The leaks have arisen due to stagnant water in the stainless steel cooling fins of the AISI 304 stainless steel wine tanks, which stood outdoors exposed to the elements for months. In southern France, where the wine tanks are located, temperatures are higher than in the north, which also promotes the development of microbiological corrosion. Additionally, the cooling fins were not internally passivated, preventing the formation of the essential protective oxide layer on the stainless steel. Stagnant water in the cooling fins can lead to microbiological corrosion, which is clearly evident here from the cutaways (see photos on page 3) at the leak locations and the microbial analysis results. It is also recommended that the stainless steel wine tank manufacturer clean the cooling fins internally after welding and then passivate them with pickling solution followed by nitric acid. Once the aforementioned chemicals have restored the oxide layer on the stainless steel, the final step is to rinse the cooling fins internally with demineralized water until no iron (Fe) is detected. The aforementioned process unfortunately did not take place here, increasing the risk of corrosion of the protective oxide layer, particularly adjacent to the welds in the heat-affected zone. Failure to remove the local drinking water also contributed to the onset of microbiological corrosion, a rapidly progressing form that led to the existing leaks and may cause further ones.

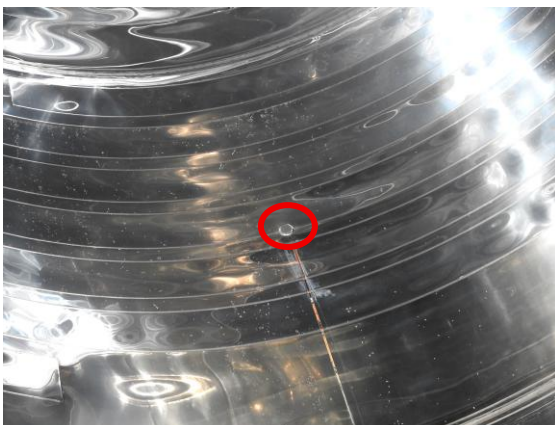
Repair old leakage

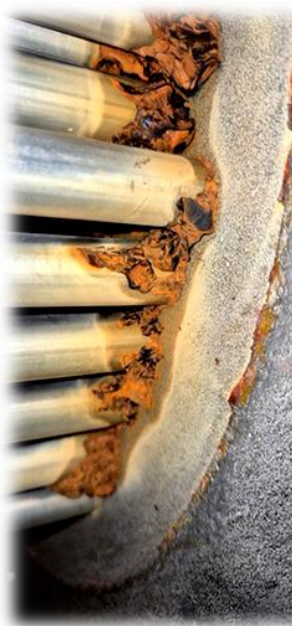
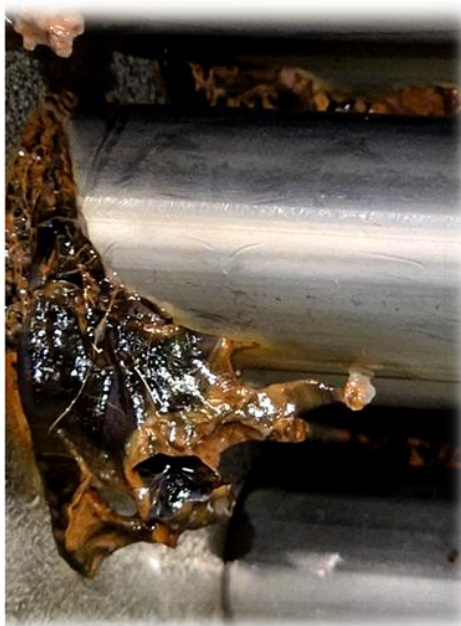
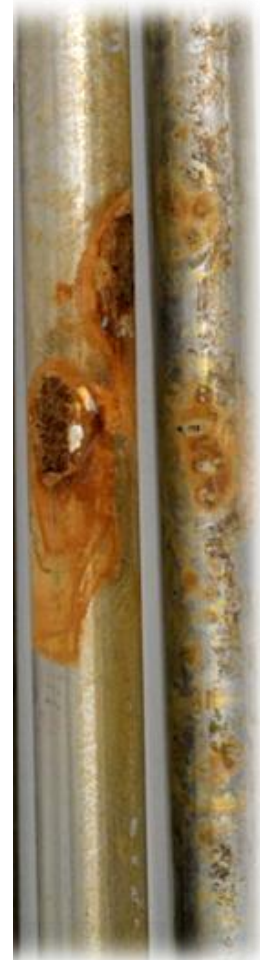
At the beginning of 2020, SARS-CoV-2 – the coronavirus that causes COVID-19 – was first detected in the Netherlands. This lasted until May 2022. During this time, many swimming pools were closed in which stainless steel mainly contained AISI 316L heat exchangers. These were also stopped during this period but not completely drained, so that water remained in them. And see here in the following photos the results of microbiological of stagnant water in the heat exchangers. More than 20 heat exchangers showed leaks during start-up!

Microbiologic corrosion AOSI 316L stainless steel heat exchangers

When the heat exchangers are idle (regardless of the type of water), the risk of bacteria is much greater than when the installation is in operation. In addition to the fact that dirt and bacteria have a greater chance of precipitating and/or adhering to stagnant water, the quality of the water deteriorates due to the standstill and bacteria also have a greater chance of multiplying. The temperature of the pool water is within the range of temperatures, at which the bacteria can grow. Stagnation of the water in the heat exchanger should always be avoided. When the installation is shut down for some time, the heat exchanger must be drained and blown dry. Within the heat exchanger there are always a number of 'blind spots' and 'gaps', where there is less flow during operation. For example, in the (measuring) socks and in the support of the bundle and the bundle pipes. There is no escaping that. This again indicates that it is important that the bacteria (or algae) do not get a chance to get into the heat exchanger, are given time to nest and grow. The material used for the heat exchangers (AISI 316L) is suitable for swimming pool water.

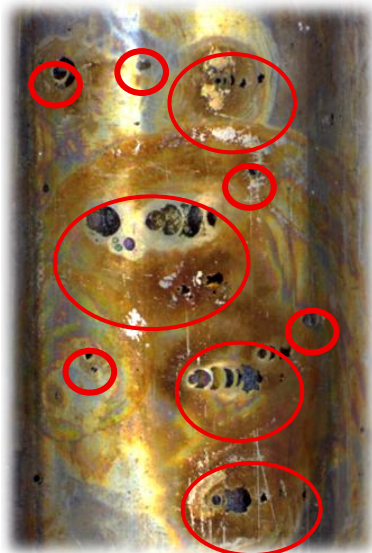
**As leaky as a sieve**

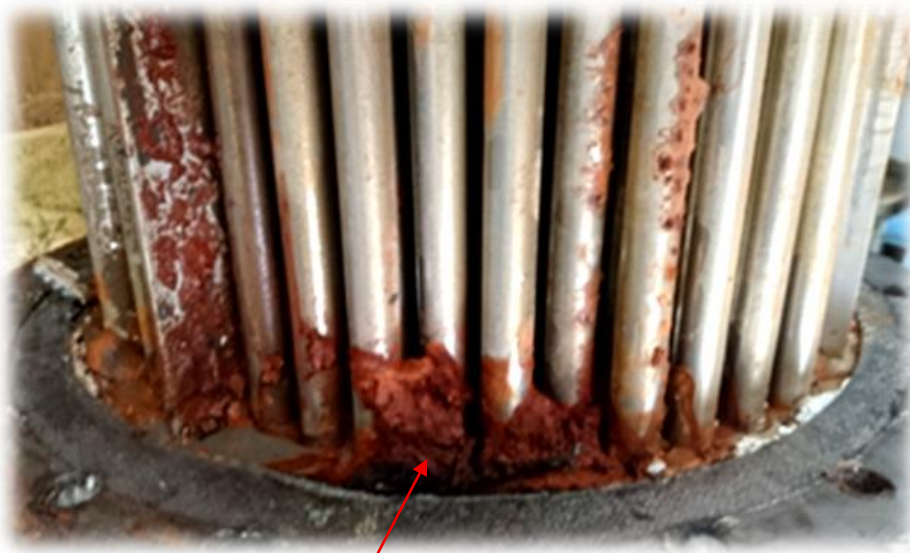
**Clear form of microbiologic corrosion at the end of the tubes**
