Stress corrosion cracking of stainless steels in swimming pools

Jan J.M. Heselmans
Jaap E.H. van Duijn
CorrOcean bv, Leiden (NL)

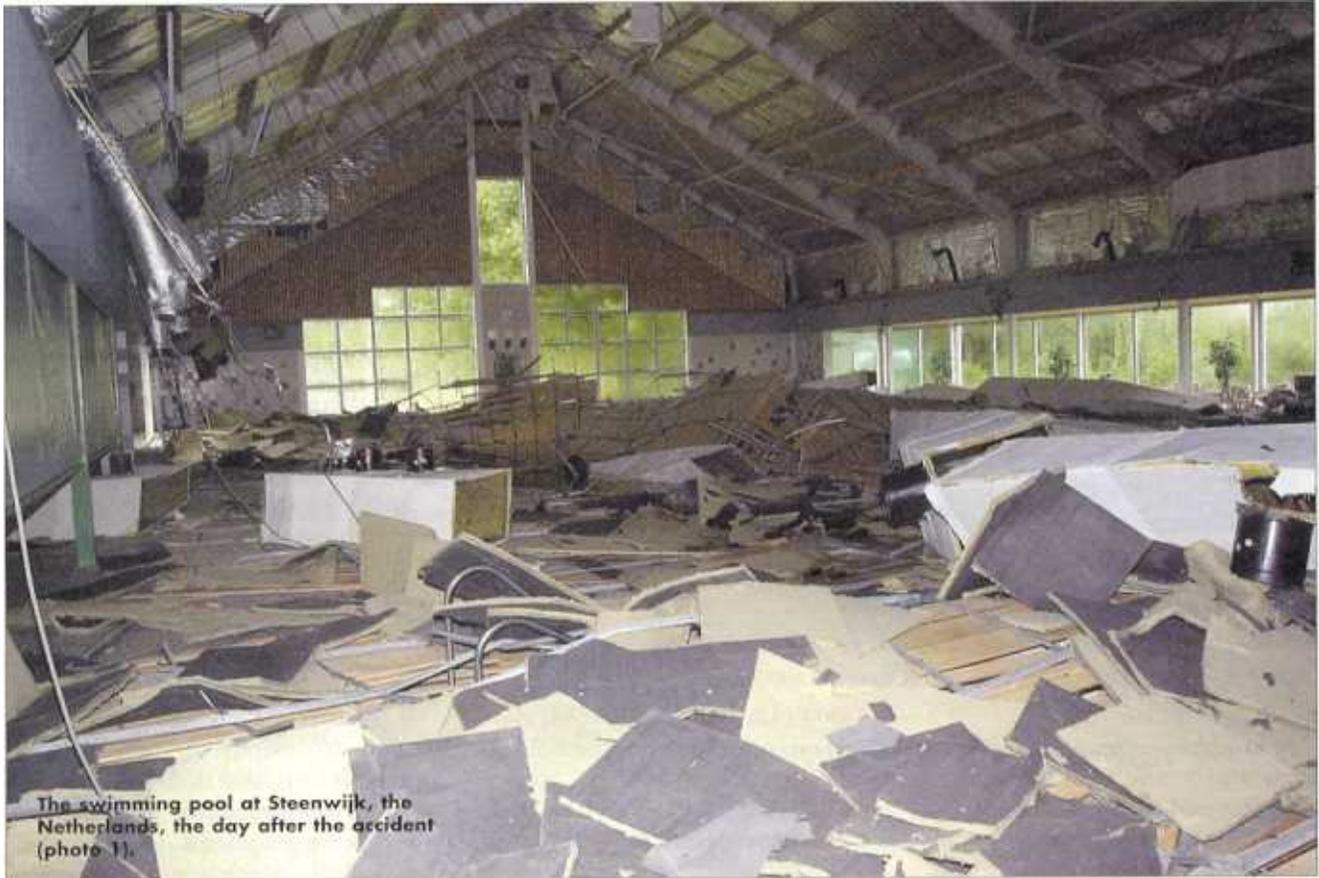
The swimming pool at Steenwijk, the Netherlands, the day after the accident (photo 1).

On the morning of 9 June this year, the staff of a nine-year-old swimming pool in Steenwijk, the Netherlands, opened the doors as usual and got the surprise of their life. The whole ceiling and the air channels were lying in the water and round the edges (photo 1). It took some seconds for them to realise that they and their visitors had escaped a human tragedy. It was fortunate that the event had occurred at night, after closing hours. A similar accident, with far worse conse-

Soon after the accident in the Netherlands, its cause became clear. Air channels above the ceiling, weighing hundreds of kilograms, had fallen onto the ceiling, which could not bear the weight of this shock and consequently collapsed as well. The air channels were suspended from stainless steel threaded bars which appeared to contain many stress corrosion cracks. The conclusion was that

stress corrosion cracking of the stainless steel bars had caused the accident. In Uster too the accident was caused by stress corrosion cracking in AISI 304 stainless steel bars supporting the roof.

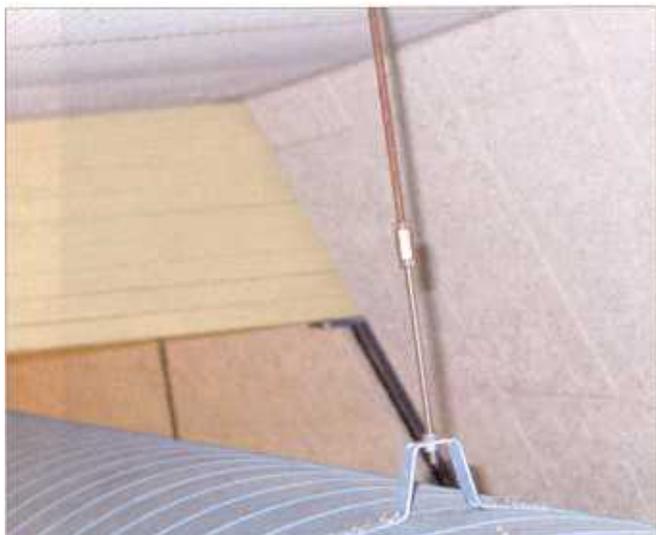
An air channel hanging on rusted and cracked stainless steel threaded bars. For unknown reason, the upper part is rusting stainless steel and the lower part is non-rusting galvanized steel (photo 2).

- Six swimming pools were at immediate risk. The air channels were suspended from rusted stainless steel threaded bars (photo 2). Three of those six swimming pools were closed for repair; in the case of the other three, temporary measures (support of the channels) were adopted to reduce

the risk until further repair was done.

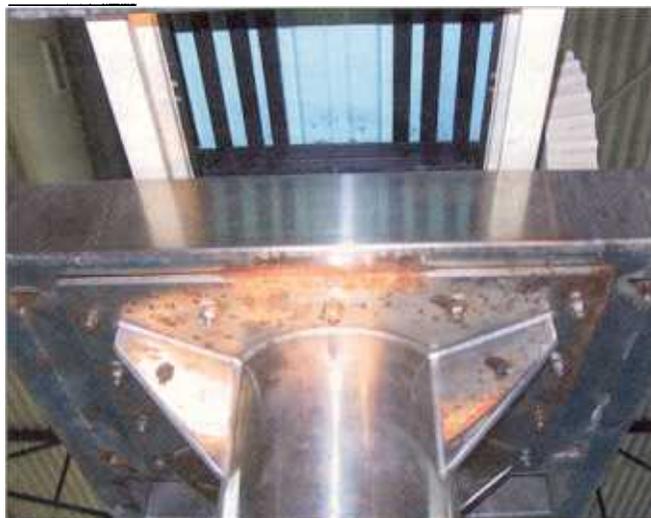
304 (A2) and AISI 316 (A4) elements rusted, not much difference being noted (photo 3).

Rusted stainless steel AISI 316 construction, after six months of use (photo 3).

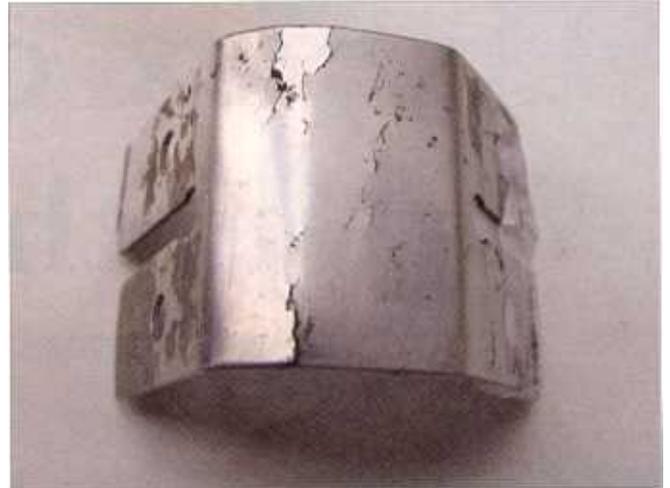
- Cold-worked stainless steels, such as fasteners, bolts, elements in ceiling hooks, etc., were often found to have stress corrosion cracks below the rust spots (photo 4).
- Most of the problems occurred in new swimming pools; two of these swimming pools were even less than one year old. Swimming pools older than 20 years did not contain critical stainless steel elements. One swimming pool, one year old, had its air channels suspended from rusting stainless steel bars and the steel roof construction bolted with stainless steel bolts.
- Galvanized steel and hot-dipped steel appears to behave much better than stainless steel AISI 304 and 316. Most important, it does not crack, and, moreover, it rusts less than the stainless steels.

Element in stainless steel ceiling hook. The rust spots have been removed. Below rust spots, the material appears to be full of (micro)cracks. The sheet material has been cold-formed and is therefore full of internal stresses (photo 4).
